Hydrogen Embrittlement of heat treatable steel plates welding

Abstract: In the paper, influence of hydrogen on mechanical properties of welded joints from heat-treatable structural steel plates were investigated. The heat treatment of welded plate specimens was performed, and then the specimens were charged with hydrogen electrolytically generated from 1 N H₂SO₄ solution. The following studies were carried out: static tensile test, hardness investigations, macroscopic metallographic investigations as well as investigations with the use of a scanning microscope. Hydrogen embrittlement of welded joints from steel plates was revealed by a distinct decrease of ductility and a slight decrease of strength. On the basis of metallographic investigations, it was found that in a fracture region there are fine pores created by the presence of hydrogen and its displacement due to formed stresses and plastic deformation. It was shown that welded joints are susceptible to hydrogen cracking in the heat affected zone and in the fusion zone.

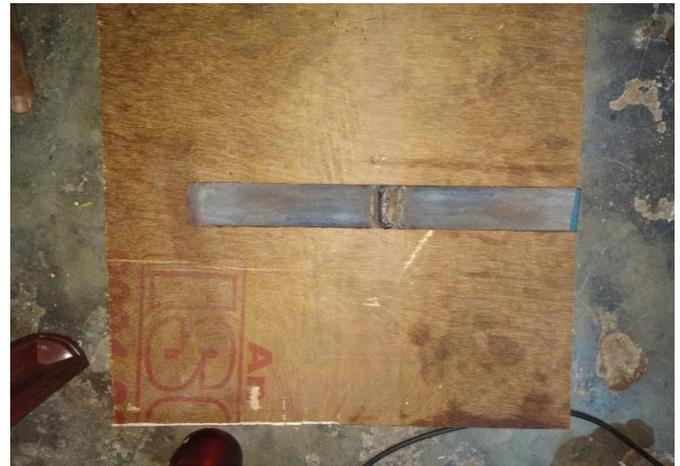
Fig 1: Welded Heat treatable steel plates.

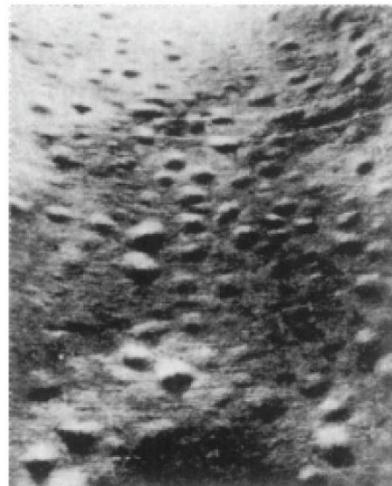
Fig 3: Hydrogen blisters in the wall of a steel container.
